PART - GROUP CHANGE NOTIFICATION				Bulletin no	2011-16	Date	01.02.2009
	Prepared by	Sabih HIZAL			Signature			
	Approved by	Alper AYDINAY						
	Copy to	TH-YPLB		ÇMI-MTK1		ÇMI-ÜPB		ÇMI-MÜT
ÇMI-KGB			ÇMI-MTK2		ÇMI-MTK3		Other

TECHNICAL EXPLANATION OF THE CHANGE**Issue** BAFFLE CHANGE**Explanation**

From February 2009 all washing machine baffles are to be fixed to the drum using 2 screws.

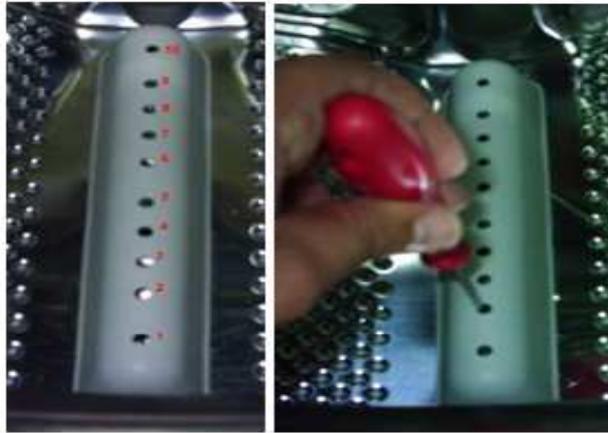
- Iron sheet tabs are pushed backwards on the wing holes by means of a flat-tip screwdriver. The iron sheet stoppers that are holding the positioning feathers are pushed backwards by inserting the screwdriver into the holes numbered 2, 6 and 10 in the drawings below according to the front view of the wing to be replaced.

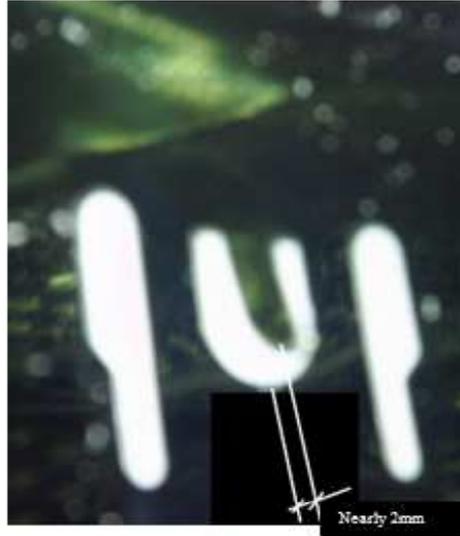
Iron sheet tabs are bent inwards to insert the wing. To do this, a flat-tip screwdriver will be useful. The point to be taken into consideration while flattening the tab is that the tip of the tab should rest appropriately. For this reason, while flattening the tab with one hand with a screwdriver, thumb of the other hand should be used to support the bottom of the tab. Thus, bending process will be carried out both in a controlled way and also appropriately. Forcing the side of the tab to make it straight may cause bending of the tab irregularly.

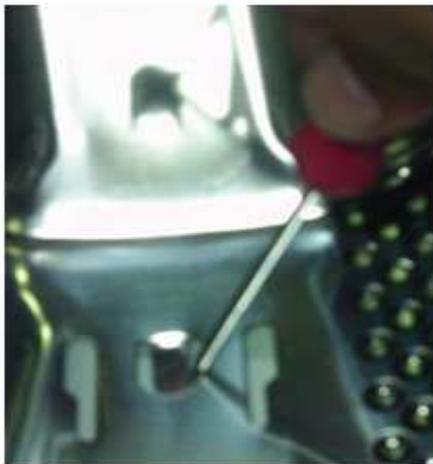
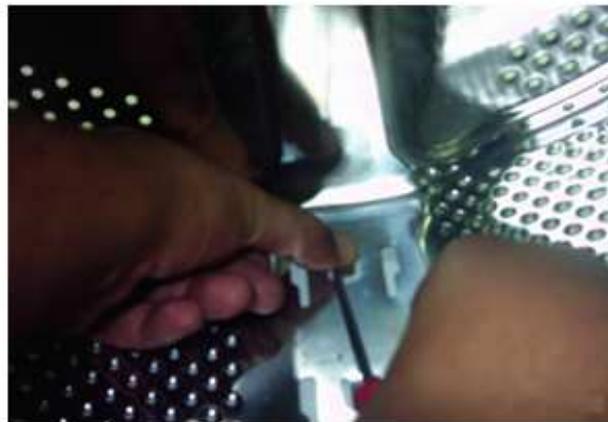
Incorrect straightening method
straightening method

Correct

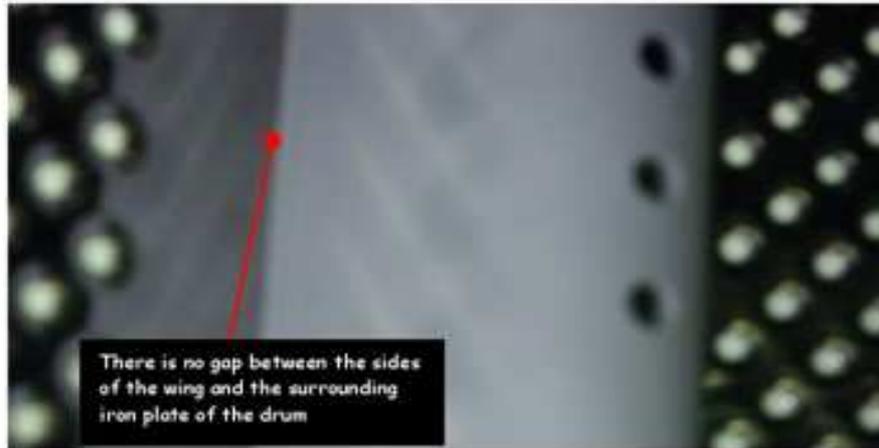
- The wing is passed through the wide slot area which has been created to pass the plastic tabs and it is pulled forwards (towards the mouth of the drum) to ensure passing of the iron sheet tabs. When the iron sheet tabs are seated behind the wing's stopper feather, a "click" sound will be heard. At the end of the mounting process, there should be no gap between the sides of the wing and the surrounding iron plate of the drum.

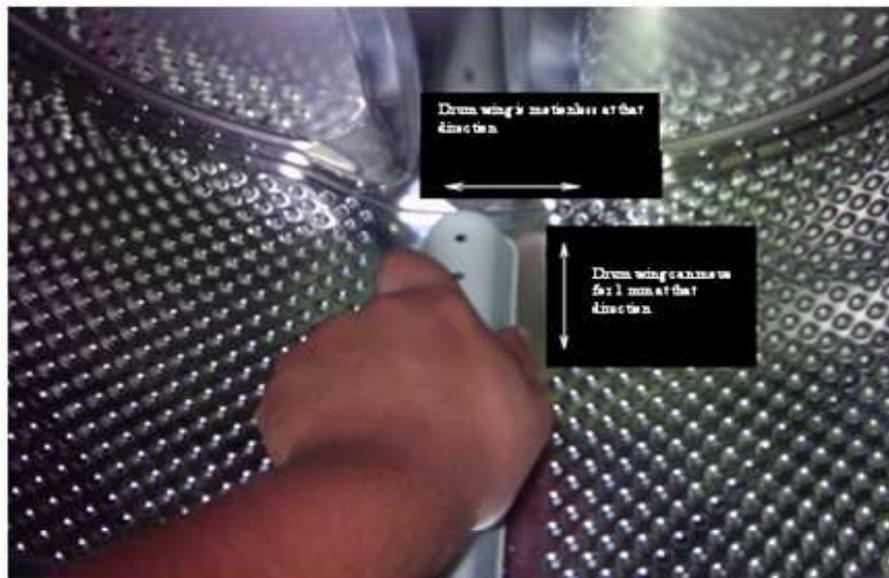
- To check if the mounting is made correctly, the wing is forced backwards and sidewards. If it does not come out or if it does not move too much, the mounting is completed.
