PART - GROUP CHANGE NOTIFICATION				Bulletin no	2011-16	Date	01.02.2009
	Prepared by	Sabih HIZAL			Signature			
	Approved by	Alper AYDINAY						
	Copy to	TH-YPLB		ÇMI-MTK1		ÇMI-ÜPB		ÇMI-MÜT
ÇMI-KGB			ÇMI-MTK2		ÇMI-MTK3		Other

TECHNICAL EXPLANATION OF THE CHANGE**Issue** BAFFLE CHANGE**Explanation**

From February 2009 all washing machine baffles are to be fixed to the drum using 2 screws.

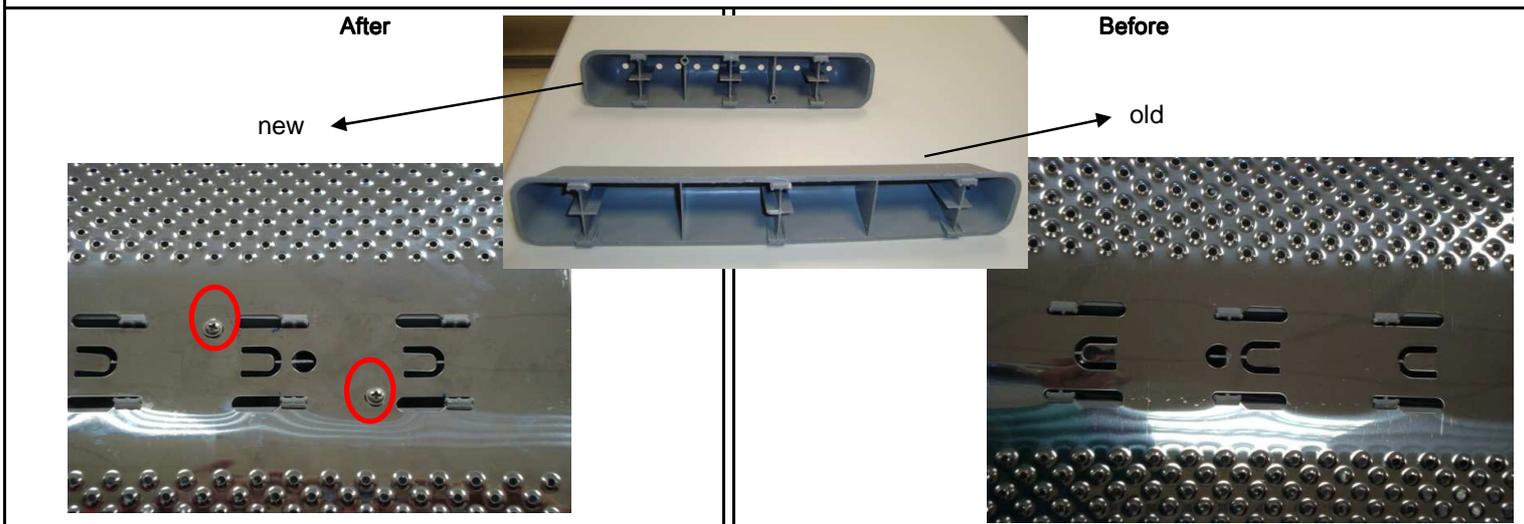
Examples for Large models:

BEKO WMD78142-EU B1 XL 8KG DMLBLDC 1400 TS A+

BLOMBERG WAF8422A-EU B1 L 8KG B56FML1200 TSA+

For the models with welded tubs: The tub/drum assembly group will need to be changed.

For other tub types: The baffles can be unscrewed and new baffles can be fixed after disassembling the tub.

For the large models: The baffle used for the rest of the models is used also for these models. By this way all the baffles are unified.
